Traffic Crash Reconstruction Report

Prepared for Melissa Self, GEICO Insurance Company

GEICO Claim Number: 0160341600101061

Harris Enterprises LLC Case Number R19-350

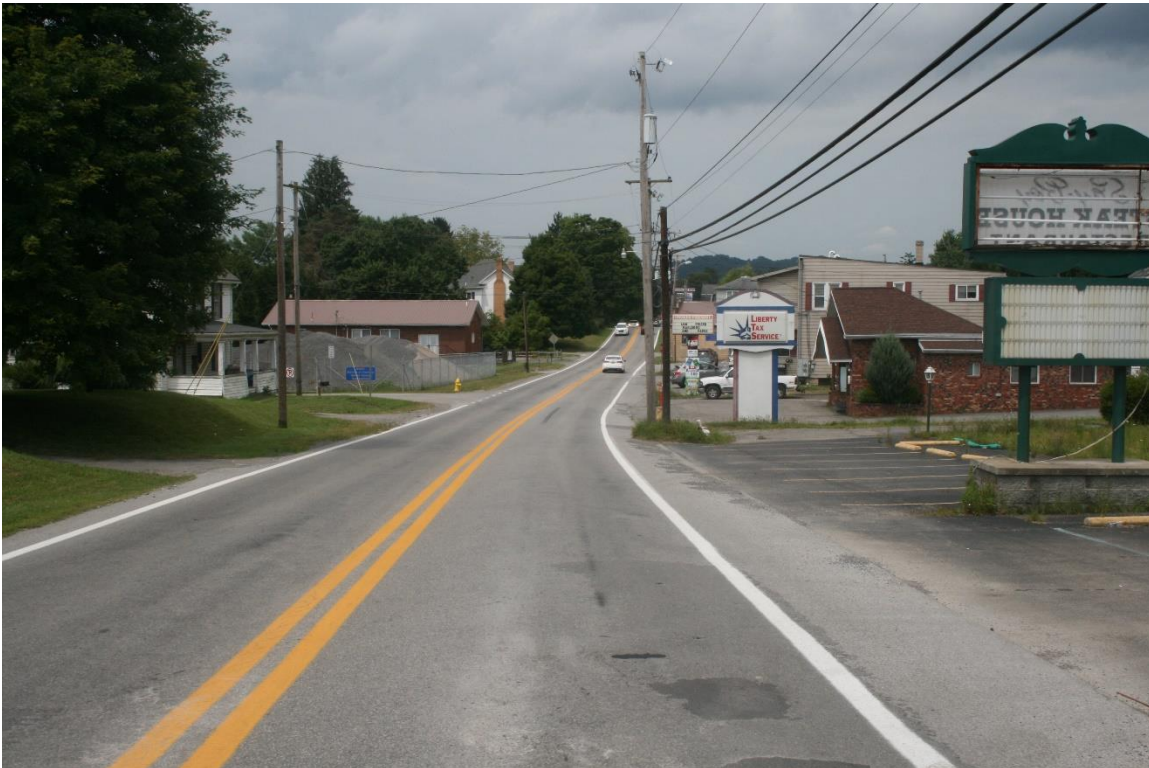
Photo 1

This view is from the direction the truck came from, and is looking towards the intersection with Bison Street, where the car came out of.

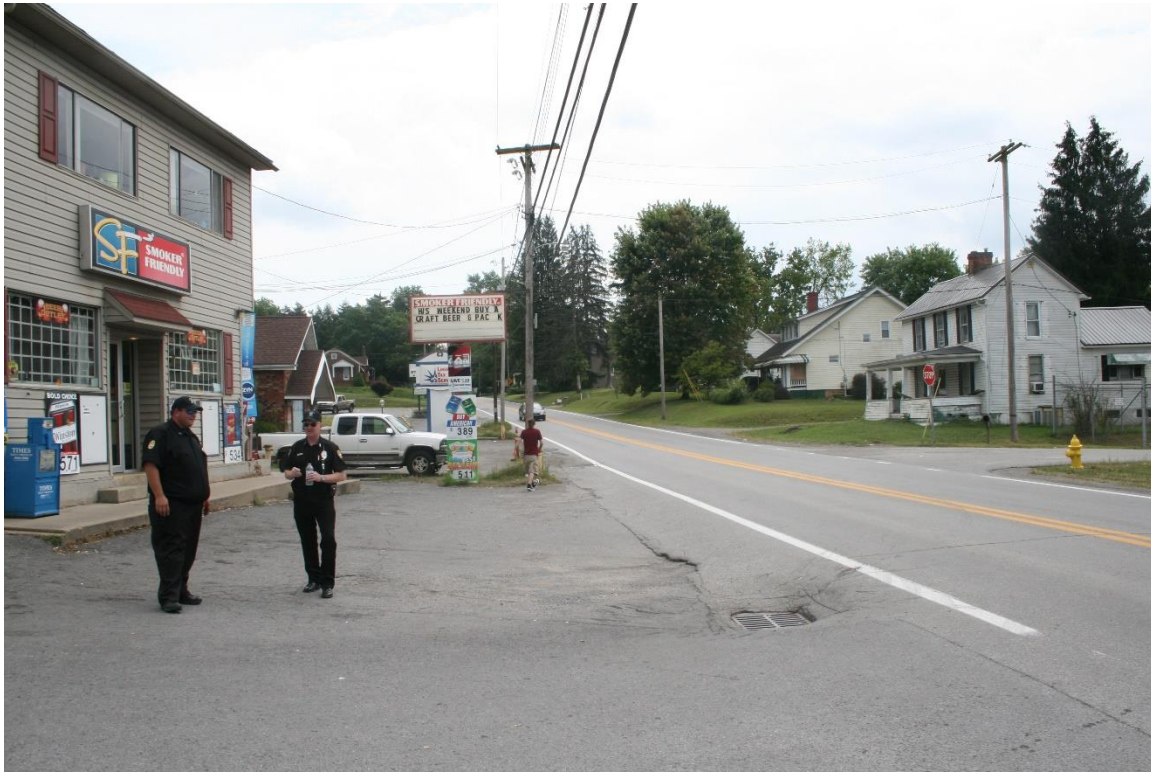
Photo 2

This view shows the view similar to what the driver of the car would have had. Included in this photo are the two Marion County Reserve Police officers who assisted with traffic control during the time that we were at the scene of the crash.

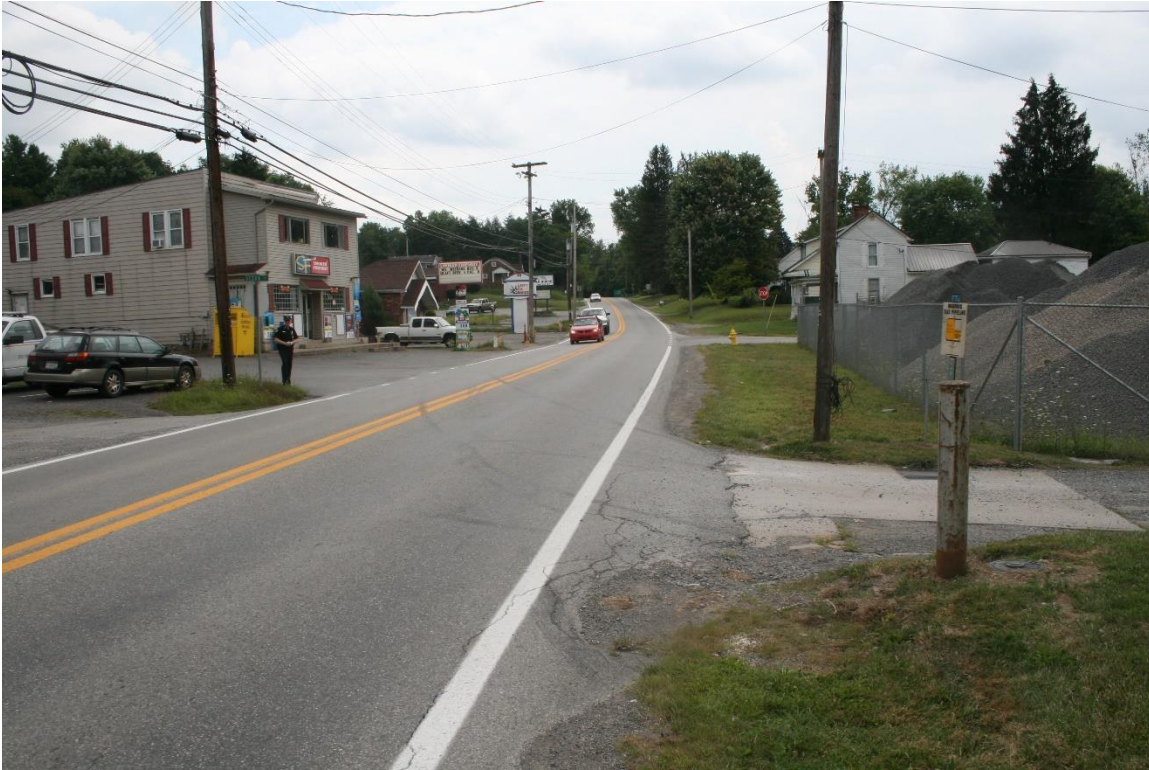
Photo 3 below shows the post-impact skid marks from both vehicles shown from the viewpoint looking from the area of final rest towards impact for both vehicles.

Notice in Photo 3 that impact appears to have occurred near the center line of the roadway. This is shown better in a closer view, in Photo 4.

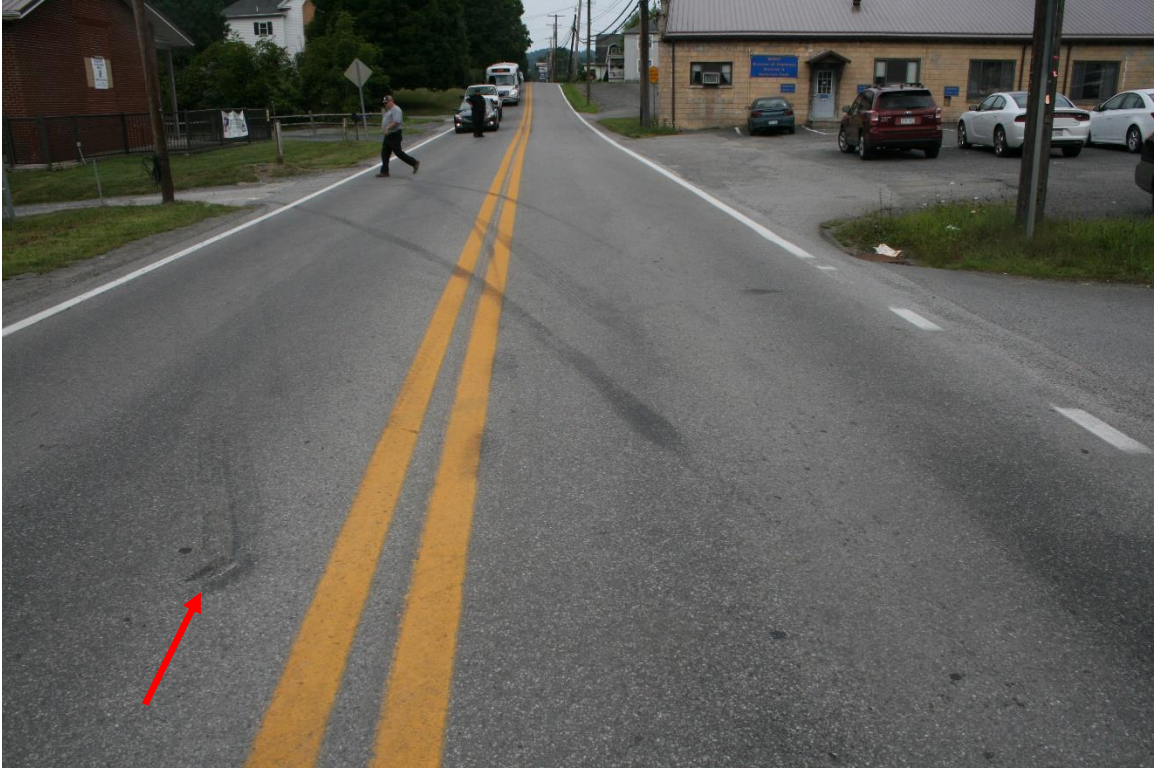
Photo 4 was taken from the direction of the pickup truck. Notice the gouge mark indicated by the **red** arrow. Further investigation revealed that this mark was made by the left front wheel of the Subaru involved in this crash. This viewpoint is from the direction the pickup truck was traveling looking towards final rest.

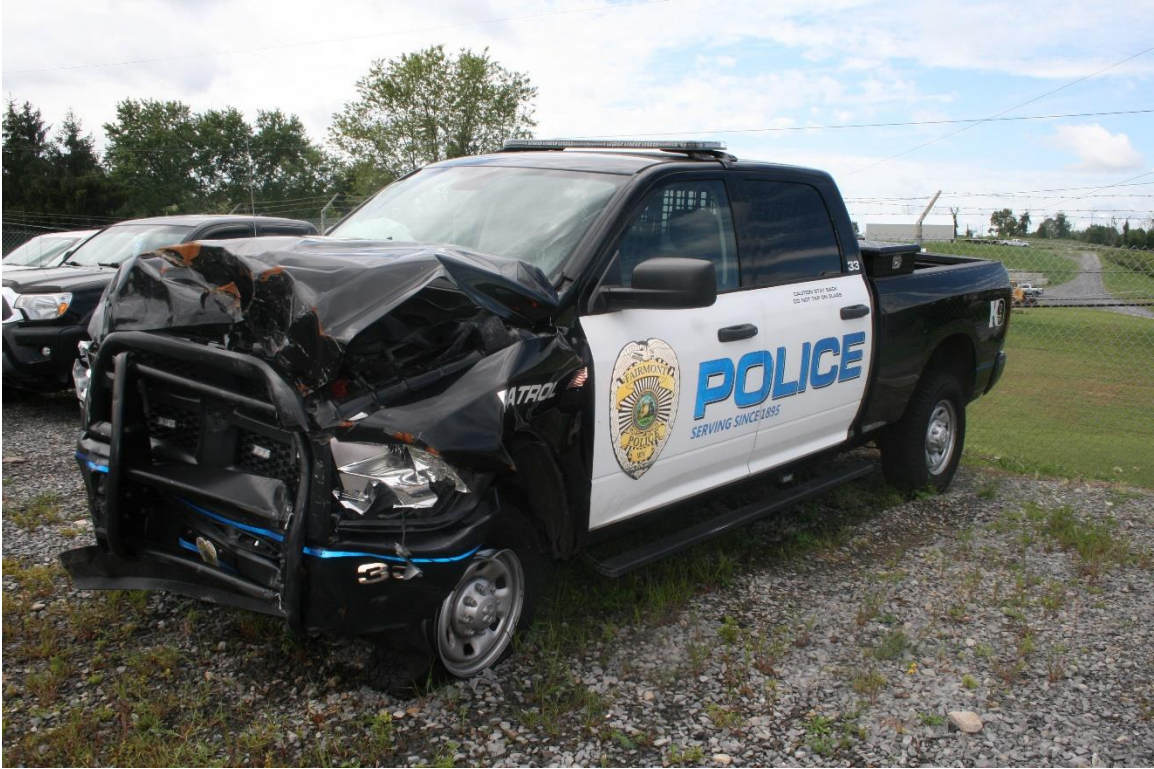
Photo 5 shows the front and driver's side of the pickup truck involved in this collision. Notice that the damage is more severe towards the driver's side than the passenger side, which is shown below in Photo 6. This is due to the angle of impact and the direction the car was traveling relative to the direction of the pickup truck.

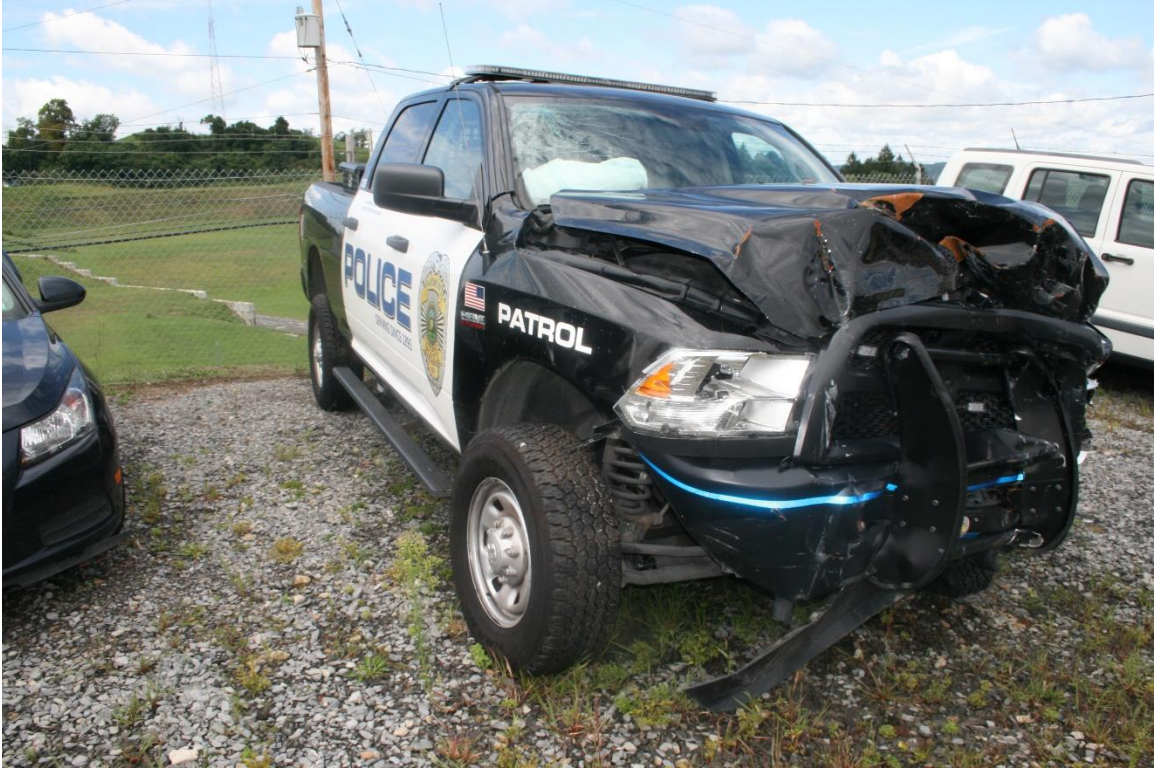
In looking at Photo 6 above, the difference in the passenger side and driver's side damage is easily seen. Evidence of a secondary impact for the pickup truck is shown below in Photo 7.

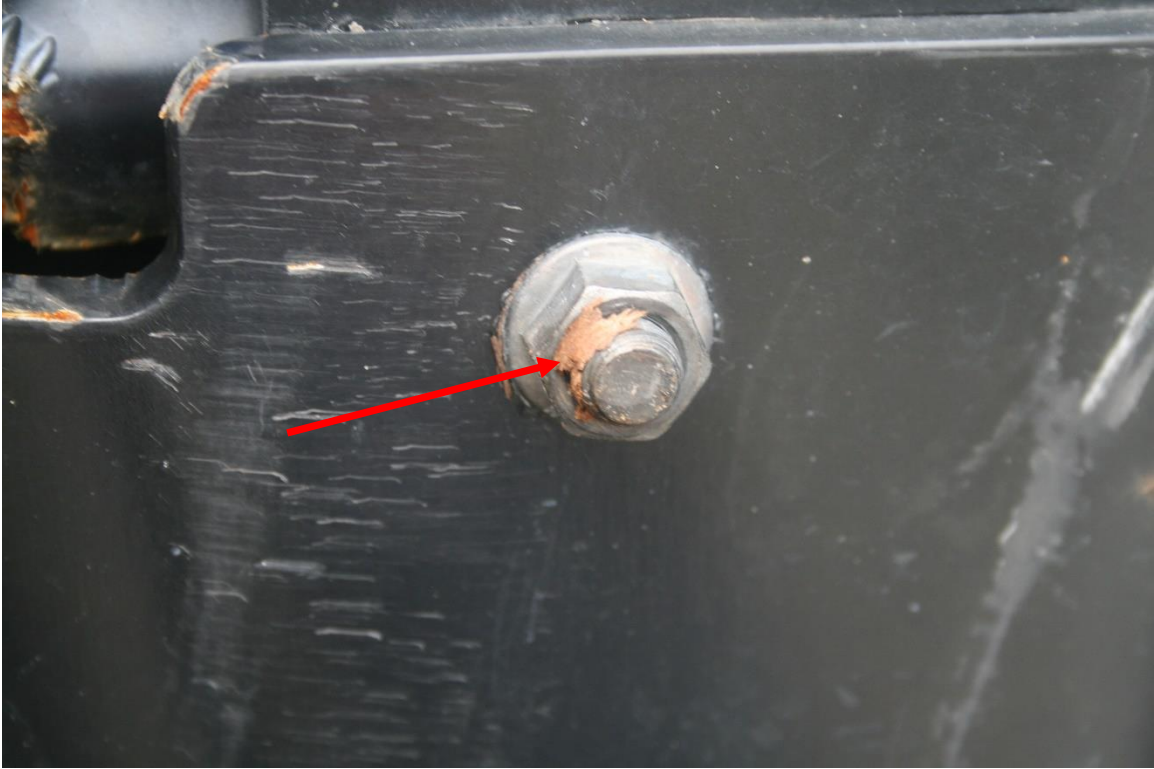
Photo 7 shows wood stuck on the bolt holding the brush guard on the driver's side of the front of the pickup truck. The pickup truck did strike the telephone pole after striking the car, as evidenced by this, the pole showing damage and being moved, as well as the download report, which will be discussed later in this report. The wood is indicated by the **red** arrow.

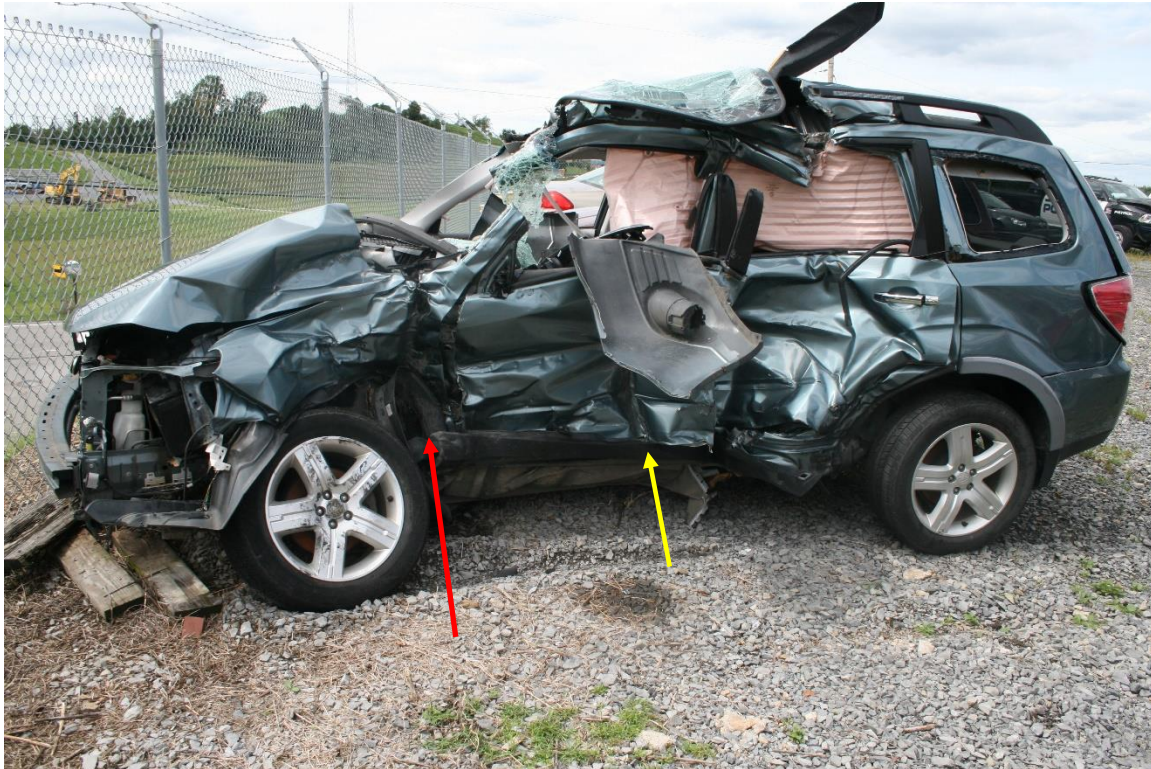
Photo 8 shows the driver's side of the Subaru involved in this crash. One can see where the driver's side upright of the brush guard of the pickup truck struck the car during maximum engagement. This is indicated by the **red** arrow. It also appears that the passenger side upright on the brush guard struck the car where the **yellow** arrow indicates. This alignment also indicates that the center of mass of the pickup truck nearly lines up with the center of mass of the car. Evidence of a secondary impact for the car is shown below in Photo 9.

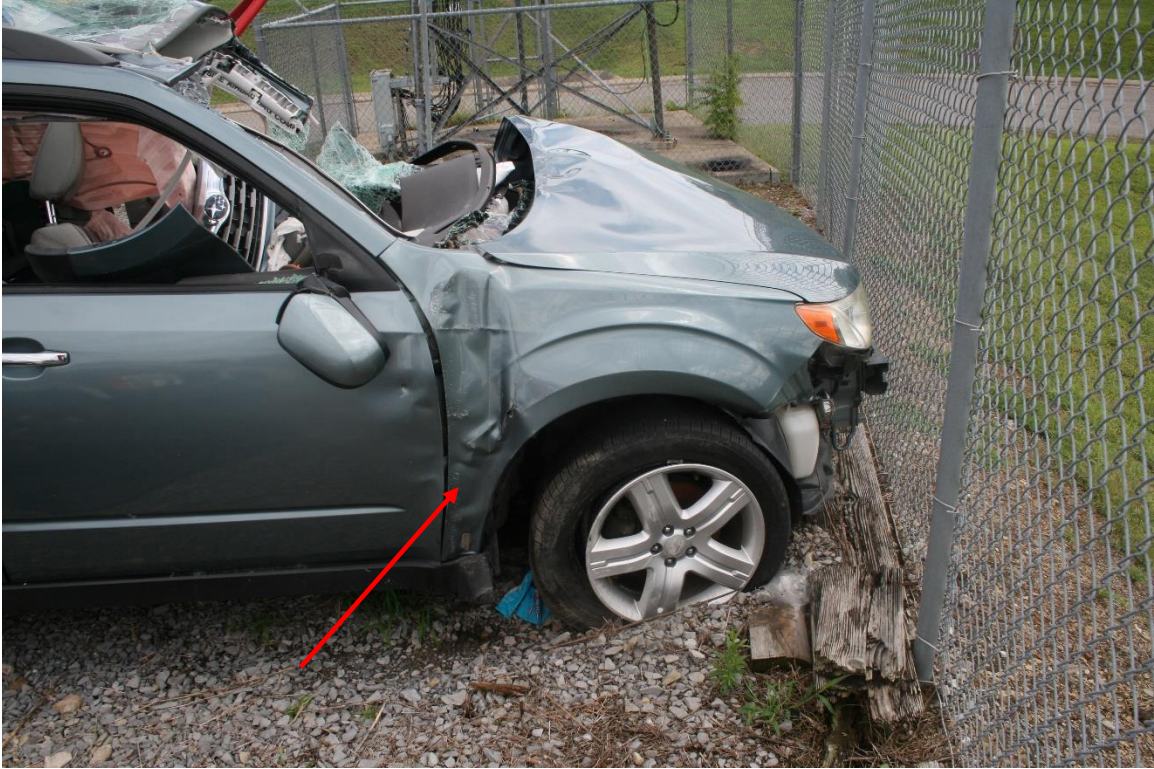
Photo 9

The secondary impact for this vehicle was with a pole located in front of building where the car came to final rest. The damage from the secondary impact is indicated by the **red** arrow.

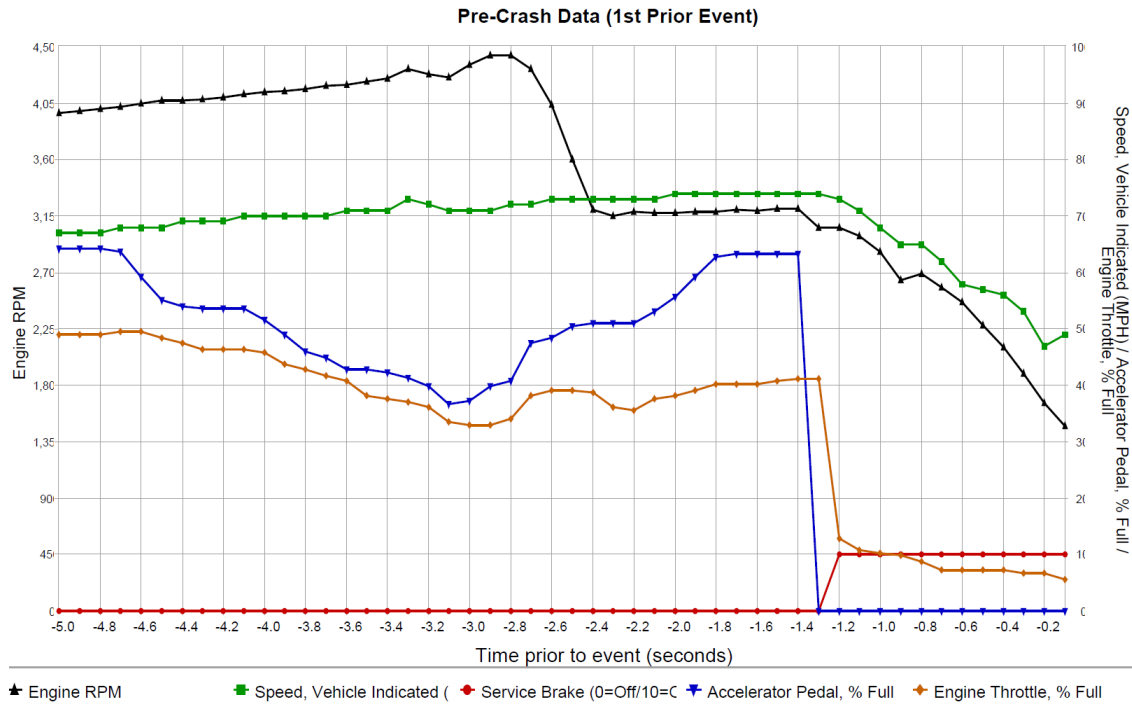
The above graph shows the pre-impact data in graphical form. The service brake (in **red**) shows either on or off and does not indicate how hard the brakes were depressed, only if the brake circuit switch was off or on.
